Portland Harbor Sediment Superfund Site
Technical Memorandum:
Results of Seep Reconnaissance Survey
River Mile 2 – 10.5
Lower Willamette River

DRAFT
February 18, 2003

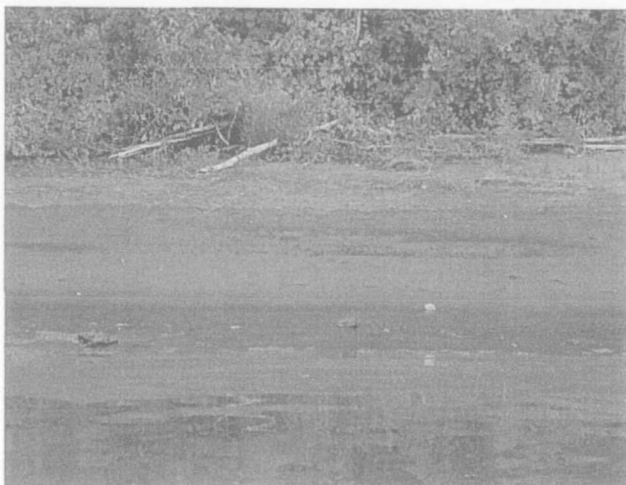
Photo 1: East side of Swan Island Lagoon. Linear seep characterized by sheetflow where fine-grained sediment crops out at the base of the sand. Iron oxide staining and slime associated with seepage on the upper part of the beach above main seep line.

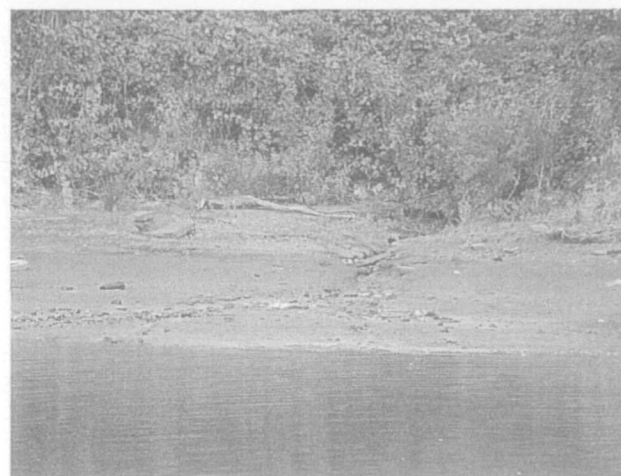
Photo 2: Beach on east side of Swan Island Lagoon. Linear seep at base of beach where fine-grained sediment crops out. Seep is incised by rills due to discharge from steep bank behind beach.

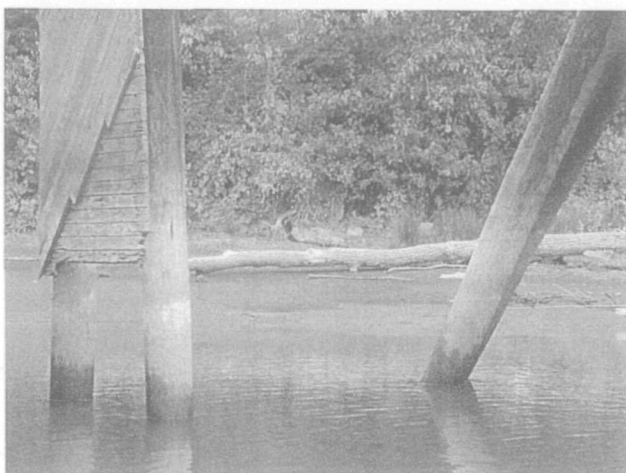
Photo 3: Pier at east side of Swan Island Lagoon. Linear seep line approximately 10 feet long characterized by sheetflow emerging at base of sand where fine-grained sediment crops out. Vegetation line along base of steep bank at head of beach.

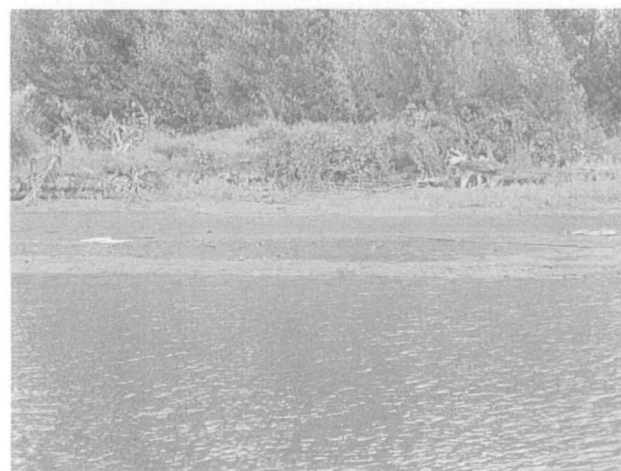
Photo 4: Beach to south of Fred Devine Salvage pier. Linear seep line approximately 20 feet long characterized by sheetflow emerging from base of sand where fine-grained sediment crops out. Vegetation line along base of steep bank at head of beach.

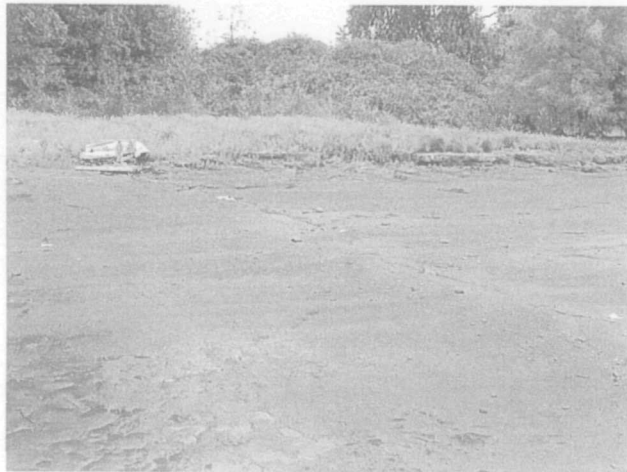
Photo 5: Closeup of beach to south of Fred Devine Salvage pier. Linear seep approximately 20 feet long characterized by sheetflow emerging from base of sand where fine-grained sediment crops out. Vegetation line at head of beach and base of steep bank.

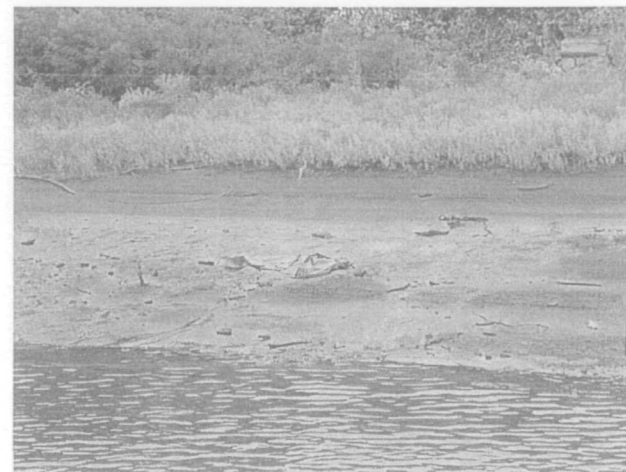
6/7	10/7/2002	7633213.391	701937.3377	North end of beach at south end of Coast Guard docks, Swan Island Lagoon	Linear discharge along ~10 - 15' approximately 8 - 10' up the beach. Discharge occurring on top of clayey material at interface between sand and clay. Rill development occurring along length of seep. iron (ferric hydroxide) staining at point locations. Seepage occurring below high tide level.	2	Sand beach over clayey/silty soil near base of beach. Short steep embankment behind the beach.
N/A	10/7/2002	N/A	N/A	Bank on north side of Swan Island Lagoon	No seeps observed	N/A	Cobbles and cobble/boulder rip rap bank
8/9	10/7/2002	7632009.637	701620.21	Bank on north side of Swan Island Lagoon. South of Beach No. 07B023.	Rills formed by rivulets discharging at base of cobble/boulder bank materials. Discharge estimated 1 - 2 gpm. Seepage originates above high tide level	1	Cobbles and boulders lining steep bank above small, sandy beaches at base. RR tracks approximately 20' above head of beach.

Photo 6: Beach at south end of Coast Guard facility in the Swan Island Lagoon. Closeup of seep line approximately 15 feet long at base of sand where fine-grained sediment crops out. Rill development due to point discharges along seepage face. Some iron oxide staining at point discharge locations. Note vegetation line at base of embankment.

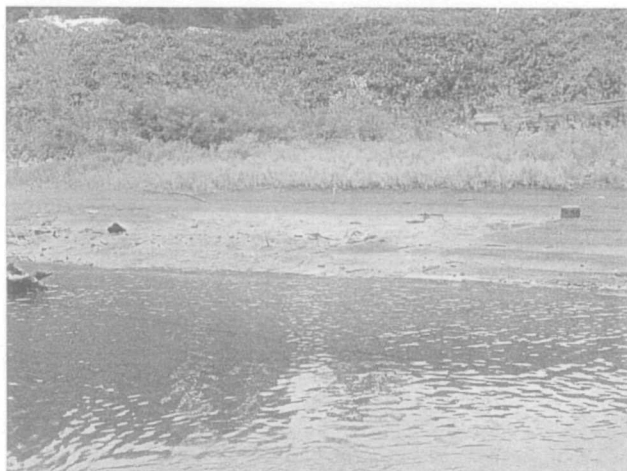
Photo 7: Beach at south end of Coast Guard facility in the Swan Island Lagoon. Distant perspective of seep shown in Photo 6.

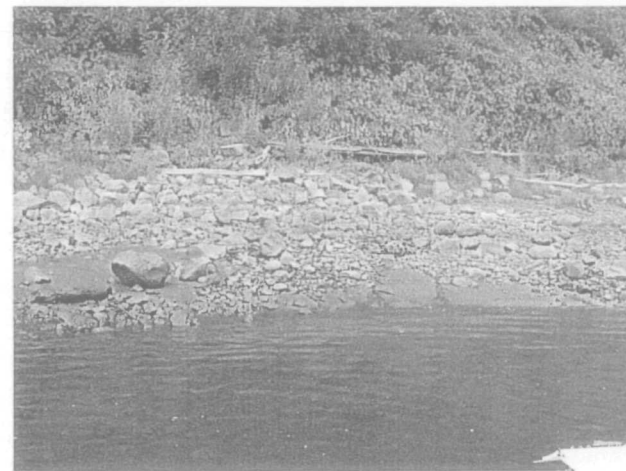
Photo 8: Bank on north side of Swan Island Lagoon. Rivulets from seep emerging beneath gravel and cobbles at base of steep embankment.

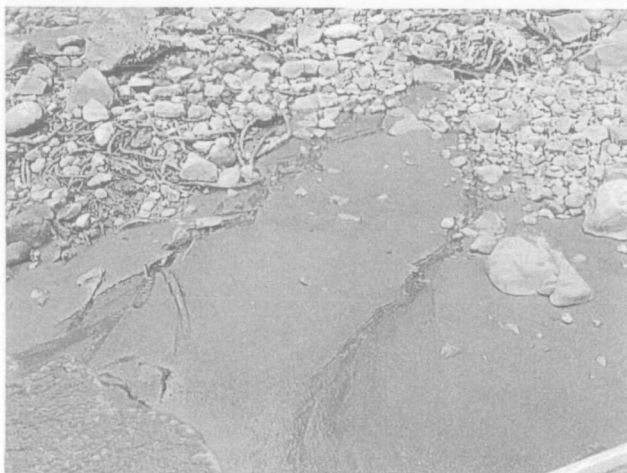
Photo 9: Bank on north side of Swan Island Lagoon. Closeup of seep emerging beneath gravel and cobbles at base of steep embankment.

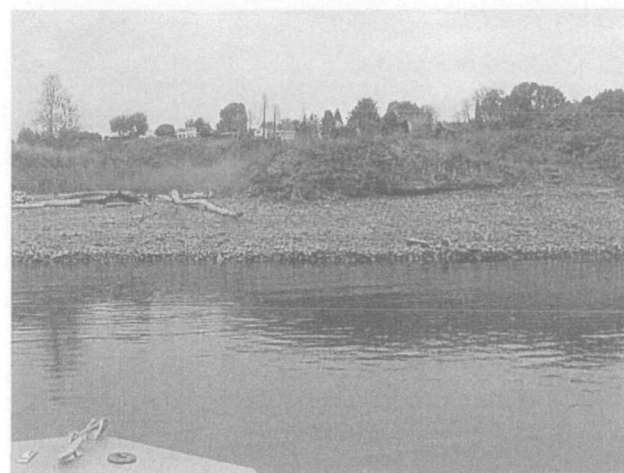
Photo Number	Date of Observation	GPS Location (Oregon State Plane North Coordinates)		General Location	Seep Description/Comments	Seep Category (See Section 3.0 of Memorandum)	Characteristics of Bank
		X Ironet	Y Ironet				
10	10/7/2002	N/A	N/A	Riedel site - beach	Iron (ferric hydroxide) staining on beach cobbles over 10' stretch of beach. Area is dry - possible seasonal seep. Area is above high tide level	5	Cobble beach
N/A	10/7/2002	N/A	N/A	McCormick & Baxter Superfund Site	No seeps observed	N/A	Riprap up to sand and sand/gravel beach. Steep, short bank above beach
N/A	10/7/2002	N/A	N/A	McCormick & Baxter Superfund Site to RR bridge	No seeps observed. Submerged seeps of NAPL reported in this area by EPA	N/A	Sand beach up to near RR bridge - riprap under RR bridge
11	10/7/2002	7627314.972	705337.4579	Adjacent to Beach No. 06B022. McCormick & Baxter Superfund Site on south side of Willamette Cove.	Approximately 70+' of bank with containment booms. Hydrocarbon smear zone visible across tidal fluctuation zone on bank. No apparent seepage above river level.	4	Sand with gravel beach below riprap embankment.

Photo 10: Riedel/Triangle Park, LLC Site. Possible seasonal seep where iron oxide staining is present on beach cobbles present at the base of the embankment.

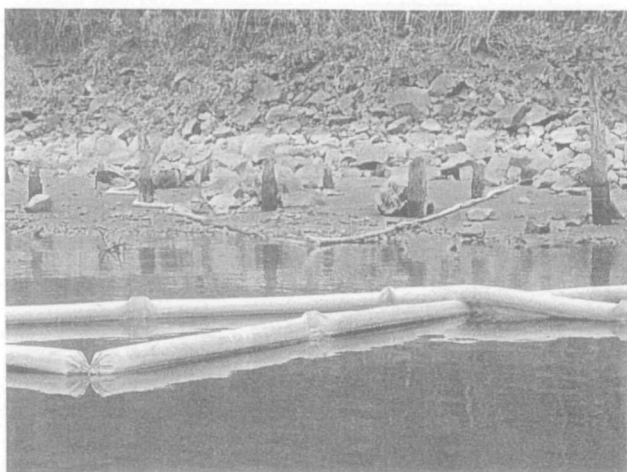
This category includes the locations of known seeps of nonaqueous phase liquids (NAPL), based on interviews with DEQ project managers and review of DEQ files. This category includes the McCormick & Baxter Creosoting Site (Photo 11), and the Port of Portland Terminal 4, Slip 3 (Photo 13) seeps. Evidence of NAPL seepage at either site was not observed during the survey. The seepage of fuel oil from Terminal 4, Slip 3, when active, appears to occur at the interface between the shallow groundwater surface and the river, which is obscured within the matrix of cobble-sized riprap behind wood pilings. In contrast, the seepage of creosote at the McCormick & Baxter site occurs in submerged shallow areas. Sheens also have been observed in the past associated with several of the seeps catalogued under Category 3, including at the Willbridge Bulk Fuel Terminal where storm drain backfill has acted as a preferential pathway.

Photo 11: McCormick & Baxter Superfund Site on south side of Willamette Cove. Hydrocarbon smear across tidal fluctuation zone on beach. No visible discharge of water above the river level was observed during the survey.

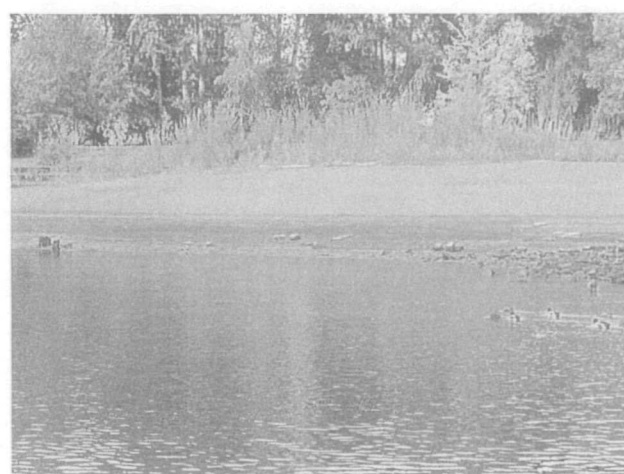
Photo 12: Cathedral Park under St. Johns Bridge. Sheetflow from linear seep discharging at base of sand where underlying fine-grained soil crops out.

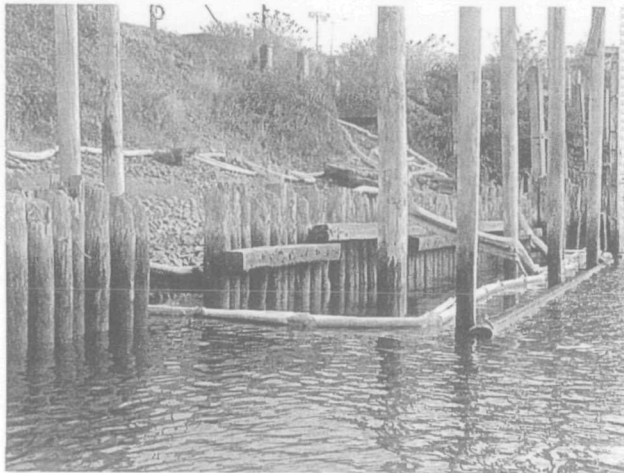
13	10/7/2002	7620487.316	713186.3491	Terminal 4, Slip 3	Historical diesel seep through cobble riprap. No visible indications of discharge of water or diesel product observed during the survey. Seep location below high tide level.	4	Steep bank with cobble rip rap
N/A	10/7/2002	N/A	N/A	North side of Terminal 4, Slip 3	No seeps observed	N/A	Sandy beach
14	10/7/2002	7620351.817	714583.9252	Terminal 4, Slip 1	Seepage at east end of slip. Diffuse linear seepage with several point discharges (estimated 1 - 2 gpm). Iron (ferric hydroxide) staining at point discharges. Thick, healthy vegetation, including cattails along seep line. Seepage above high tide level.	1	Short steep embankment above shelf of fine-grained soil (silt/clay) behind partially demolished wood retaining wall. Sand beach in front of remainder of retaining wall. Thick green vegetation on fine-grained soil along seep line.

Photo 13: Terminal 4, Slip 3. Containment boom for fuel oil seep. No seepage of water or petroleum observed during the survey.

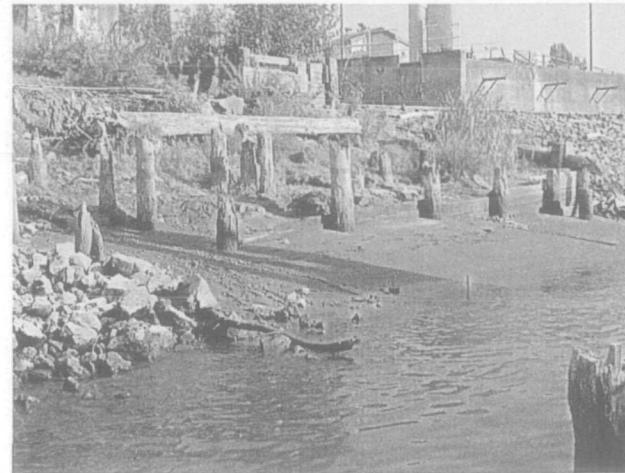
Photo 14: East end of Terminal 4, Slip 1. Diffuse linear seepage at base of embankment above beach. Seep marked by vegetation line. Several point discharges (Est. 1 – 2 gpm) from seep line characterized by iron oxide staining and iron bacteria slime.

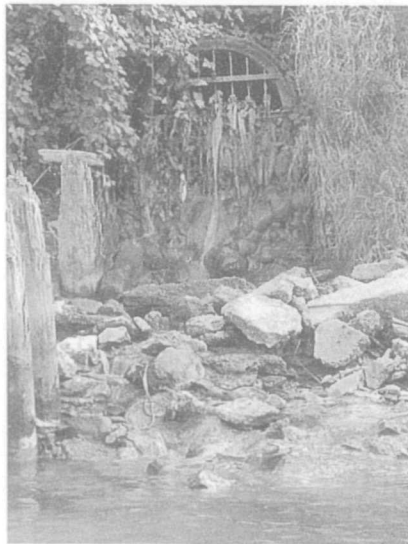
Photo 15: East end of International Terminal next to Schnitzer Site. Discharge from outfall and around backfill. Iron oxide staining and iron bacteria slime buildup.

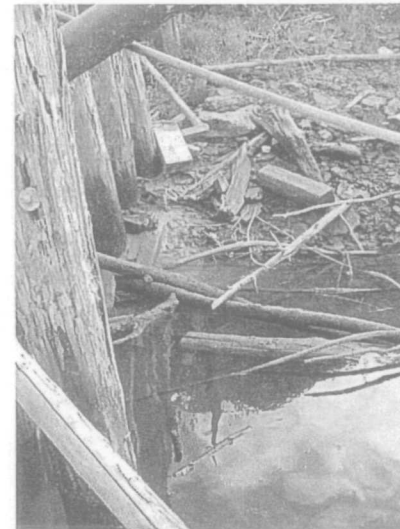
16	10/7/2002	7619963.525	717026.3675	East end of International Terminal basin adjacent to Schnitzer Investment Property.	Seepage with iron (ferric hydroxide) staining and iron bacteria slime at the base of the steep bank and above beach next to outfall.	1	East end consists of a short, steep bank behind and over a shelf of silty/clayey soil above the beach front.
17 - 19	10/7/2002	7619988.1120	717234.7558	East end of International Terminal basin adjacent to Schnitzer Investment Property.	Seepage with iron (ferric hydroxide) staining and iron bacteria slime at the base of the steep bank and above beach along the length of the east end of the basin. Cattails and other phreatophytes present along the seepage line. Small stream (estimated 5+ gpm) coming from the north end of the bank. The source of the stream is obscured by thick vegetation. The sides and base of the stream are stained with iron (ferric hydroxide). The majority of seepage occurs above the high tide level.	1, 2	Short, steep bank behind a shelf of silty/clayey soil above the beach front.

Photo 16: East end of International Terminal next to Schnitzer Site. Seepage at base of steep bank and retaining structures above beach next to outfall. Seepage marked by iron oxide staining and iron bacteria slime.

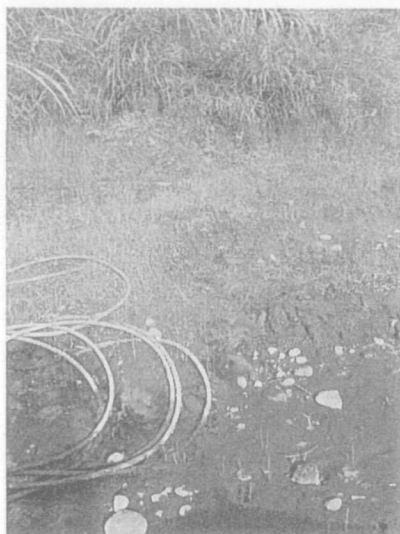
Photo 17: East end of International Terminal next to Schnitzer Site. Seepage at base of steep bank and retaining structures above beach next to outfall. Seepage marked by iron oxide staining and iron bacteria slime.

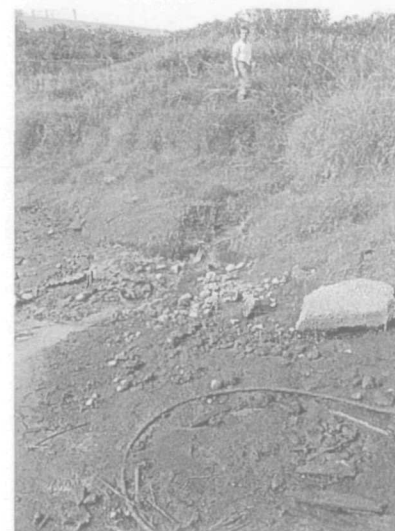
Photo 18: East end of International Terminal next to Schnitzer Site. Seepage at base of embankment at top of beach. Rivulet (Est. 5 gpm) flowing from thick vegetation at base of embankment. Iron oxide staining and bacterial slime growth evident.

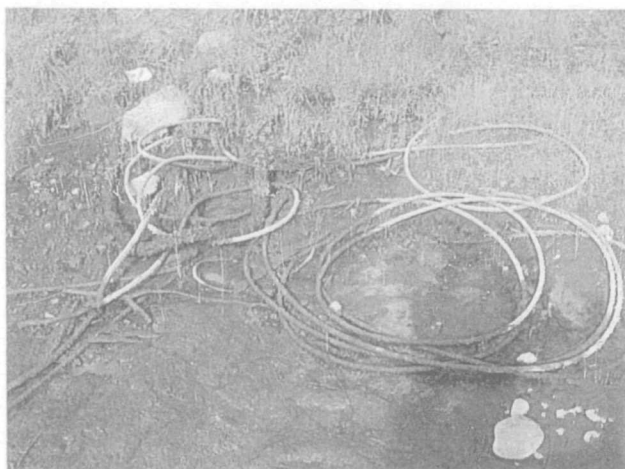
Photo 19: East end of International Terminal. Seepage at base of embankment at top of beach. Seepage marked by moss and some iron oxide staining.

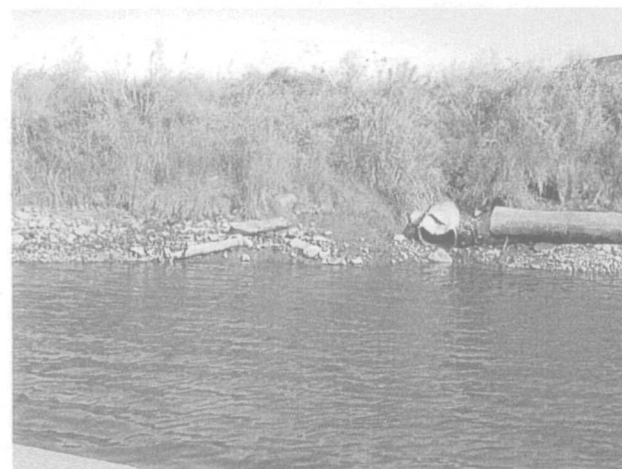
Photo 20: East end of International Terminal. Seepage from base of embankment above beach. Some seepage and iron oxide staining around outfall. Seep line at base of embankment marked by heavy vegetation.

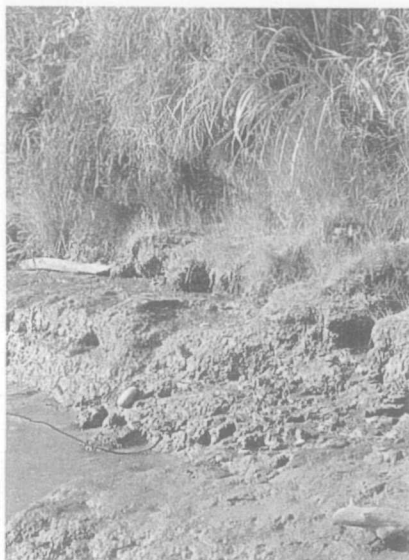
Photo 21: North side of International Terminal next to Smurfit. Seep line near base of embankment over a shelf of clayey sediment.

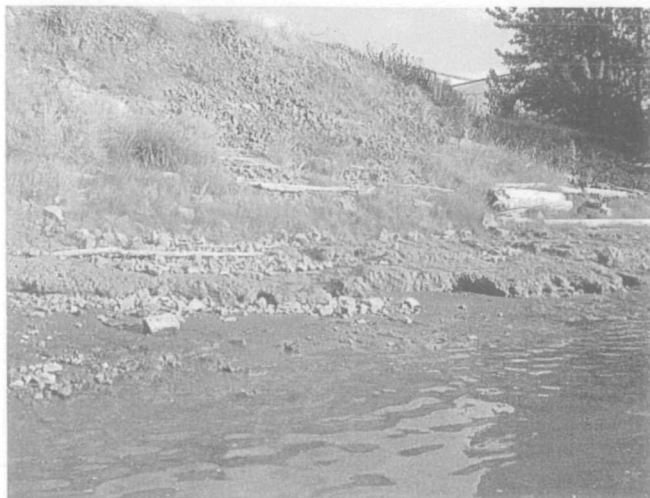
Photo 23: North side of Ash Grove Cement pier. Seepage line at base of embankment over fine-grained sediments forming the beach.

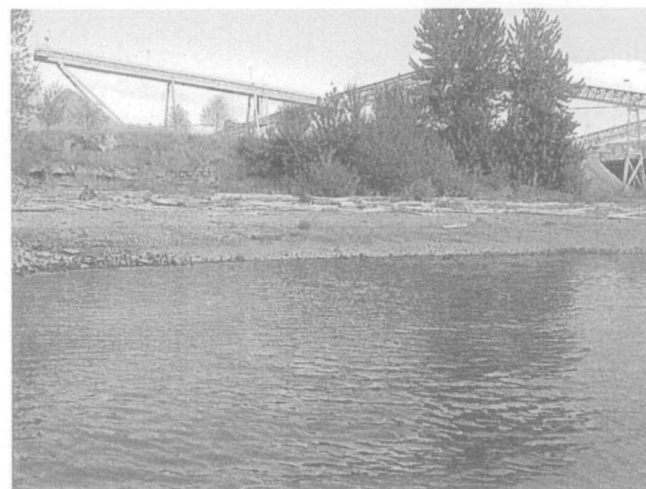
Photo 24: North side of Ash Grove Cement looking south. Linear seeps at base of the beach near the water line where fine-grained soil crops out below overlying granular materials. Iron oxide staining evident.

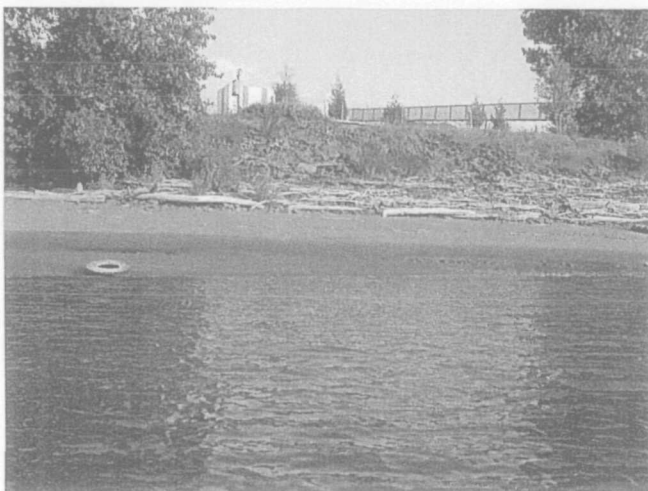
Photo 25: Simplot Site. Seepage line at base of sand where fine-grained sediment crops out.

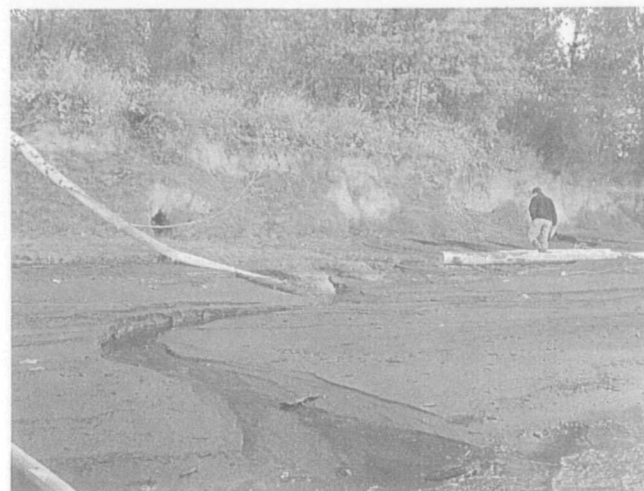
Photo 26: Next to PGE Harborton facility. Seepage along base of embankment at head of the beach. Seepage forms rills that feed into small stream.

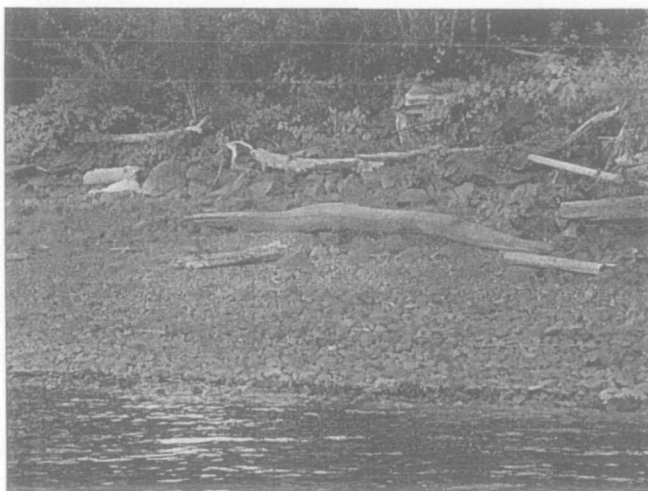
Photo 27: Owens Corning/Trumbull Asphalt site. Iron oxide staining of cobble-size riprap on steep embankment. No seepage directly observed.

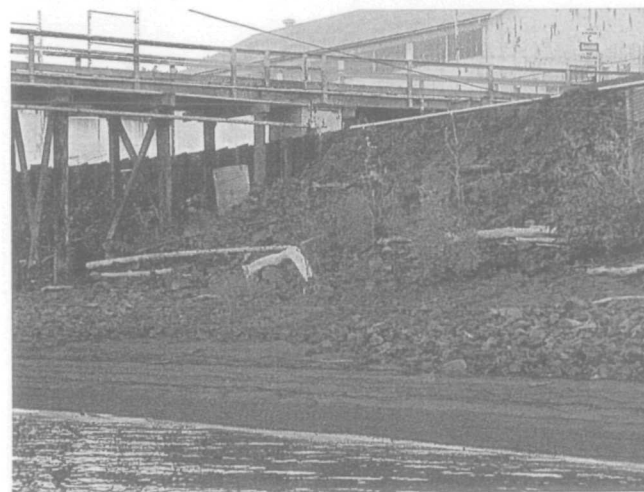
Photo 28: Owens Corning/Trumbull Asphalt site. Iron oxide staining of approximately 20' of cobble riprap above sand beach. No seepage directly observed.

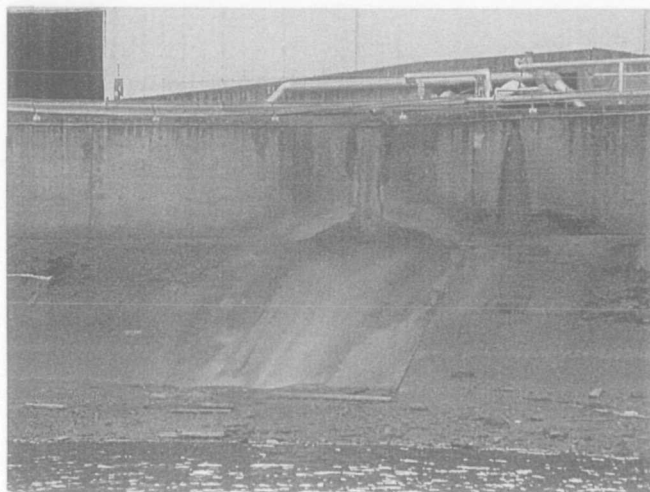
Photo 29: GATX Linnton site. Iron oxide staining along seam at junction of vertical and sloped retaining walls. Moss growth along seams and cracks. Visible seepage from seams not observed.

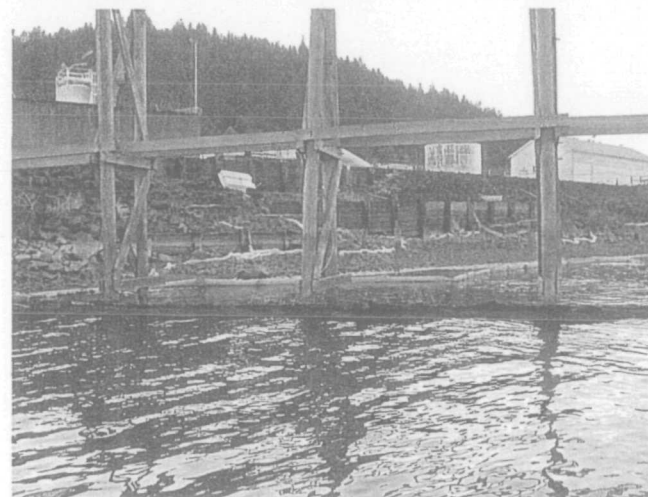
Photo 30: South side of GATX Linnton pier. Iron oxide staining of beach at base of retaining wall. Containment and sorbent booms around stained area. No visible discharge or sheen observed.

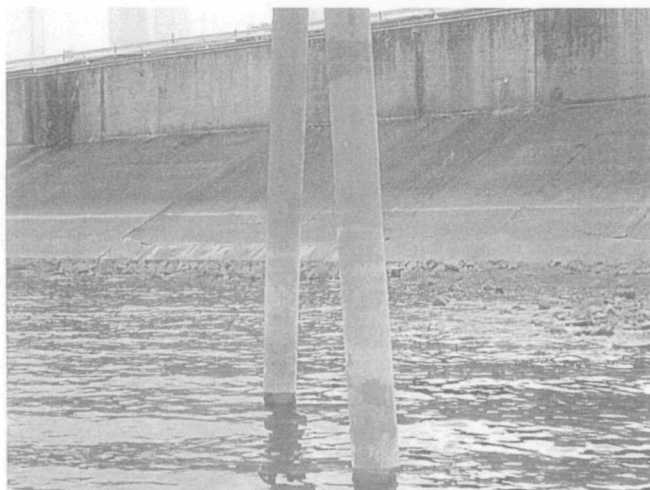
Photo 31: North side of ARCO pier. Iron oxide staining emanating from cracks and seams in concrete retaining wall. Sandy and rocky beach at base of retaining wall. No visible seepage observed.

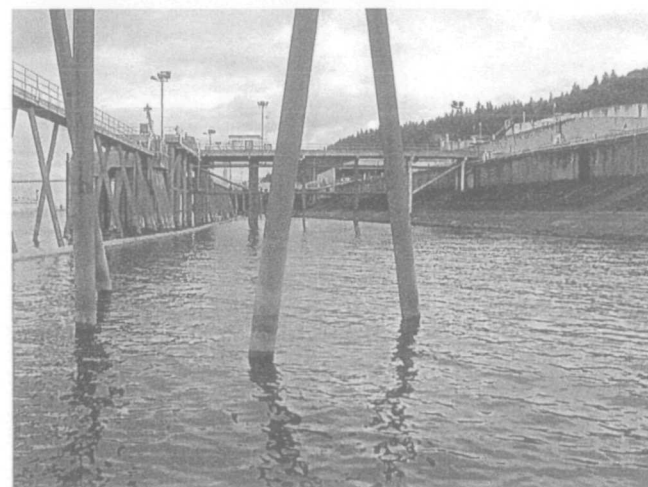
Photo 32: North side of ARCO pier looking south. Iron oxide staining emanating from cracks and seams in concrete retaining wall. Sandy and rocky beach at base of retaining wall. No visible seepage observed.

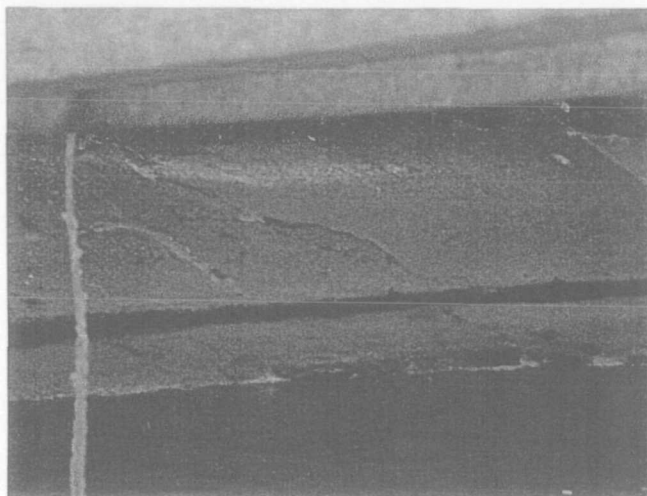
Photo 33: ARCO facility. Iron oxide staining emanating from cracks and seams on lower portion of concrete retaining wall above fine-grained sediments. No visible seepage observed.

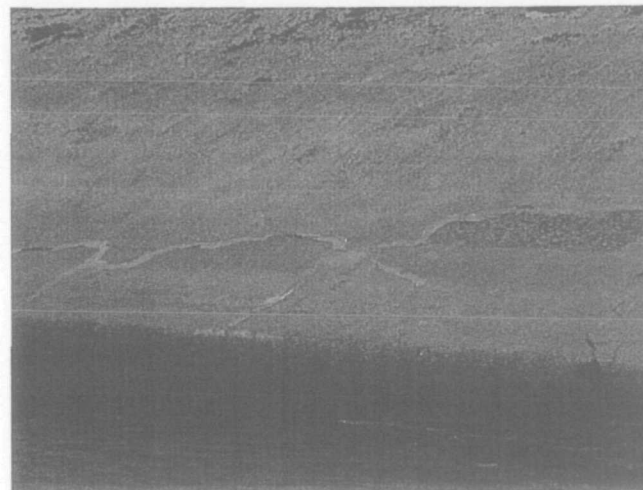
Photo 34: Mobil facility. Iron oxide staining emanating from cracks and seams on lower portion of concrete retaining wall. No visible seepage observed.

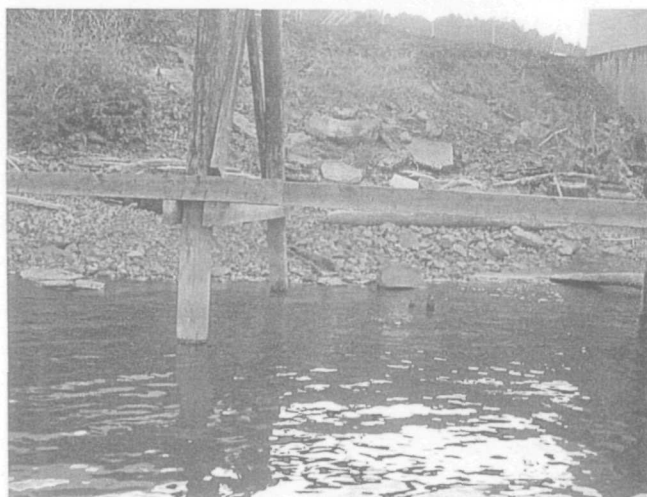
Photo 35: South end of Mobil facility. Wood plank outfall (Est. 5 gpm discharge). Iron oxide staining on cobble riprap over sandy beach adjacent to outfall. Riprap is damp and vegetated in vicinity of outfall

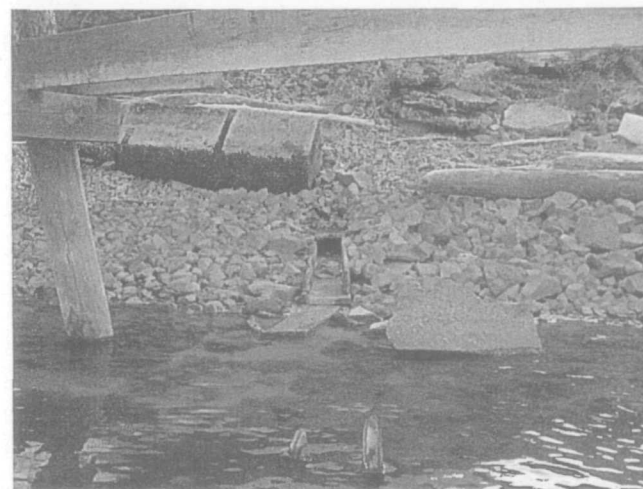
Photo 36: South end of Mobil facility. Closeup of wood plank outfall (Est. 5 gpm discharge). Iron oxide staining on cobble riprap over sandy beach adjacent to outfall. Damp and vegetated in vicinity of outfall.

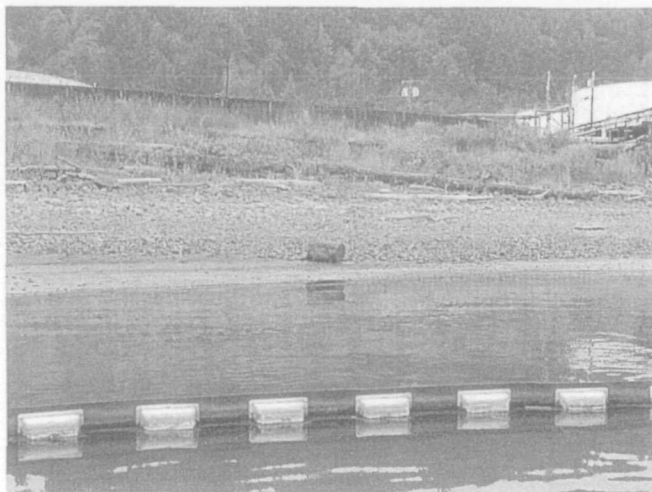
Photo 37: Adjacent to Gasco site south of pier. Iron oxide staining of rock overlying sand and mud. Apparent seepage evident at the foot of beach.

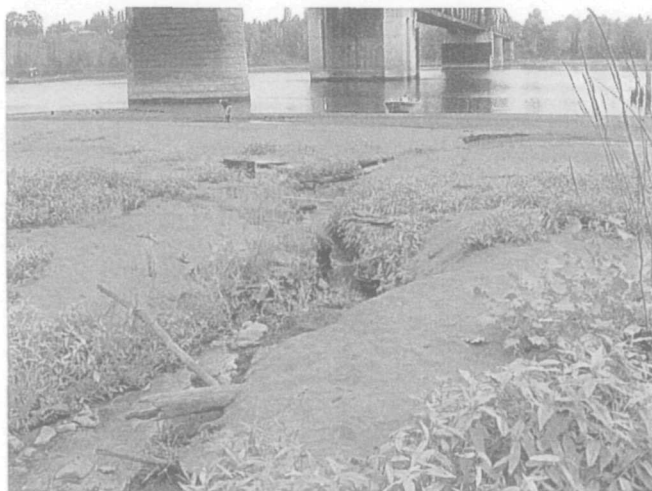
Photo 39: Beach under railroad bridge. Photo taken near the road embankment where the stream discharges onto the beach.

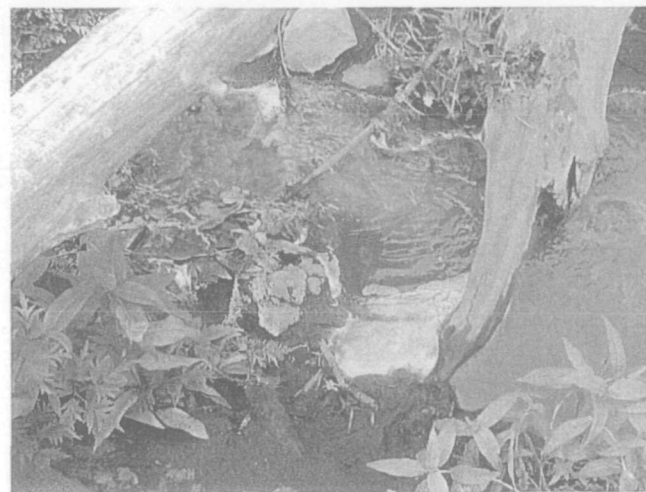
Photo 38: Beach under railroad bridge. Iron oxide staining and slime growth in stream emanating from steep overgrown bank at under south side of bridge. Source of stream likely a culvert under road.

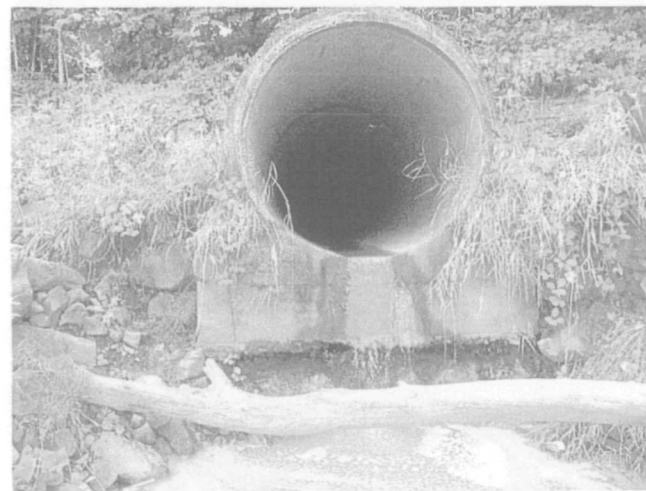
Photo 40: Beach under railroad bridge. COP Outfall 22C located under the bridge. Seepage from backfill observed at base and on sides of outfall. Iron oxide staining and iron bacteria slime growth.

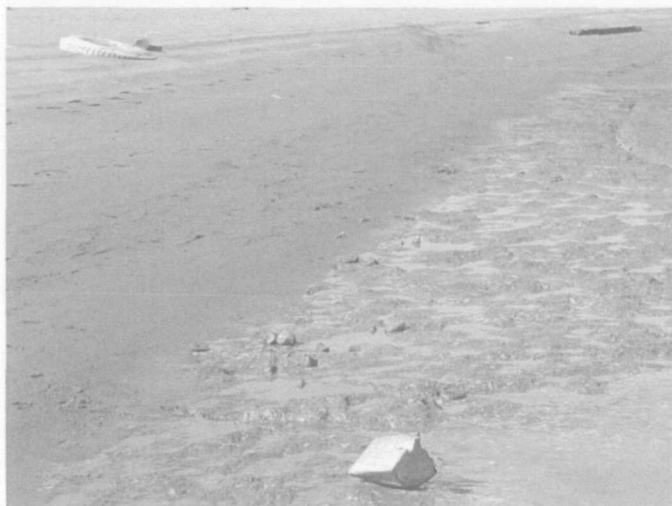
Photo 41: Beach on north side of Willbridge basin. Seep line where fine-grained sediments crop out under the sand at the foot of the beach.

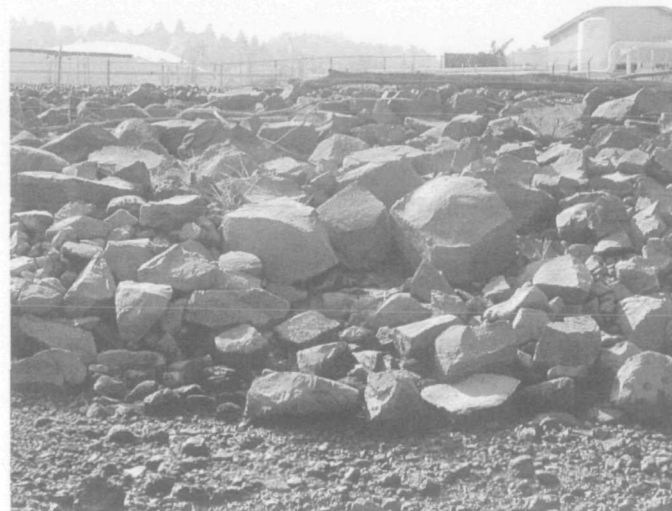
Photo 42: Chevron facility. Closeup of water discharging under boulder riprap. Iron oxide staining of boulders.

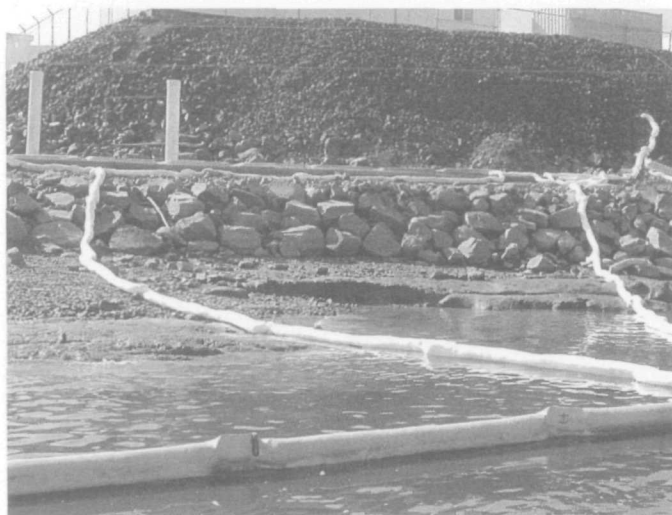
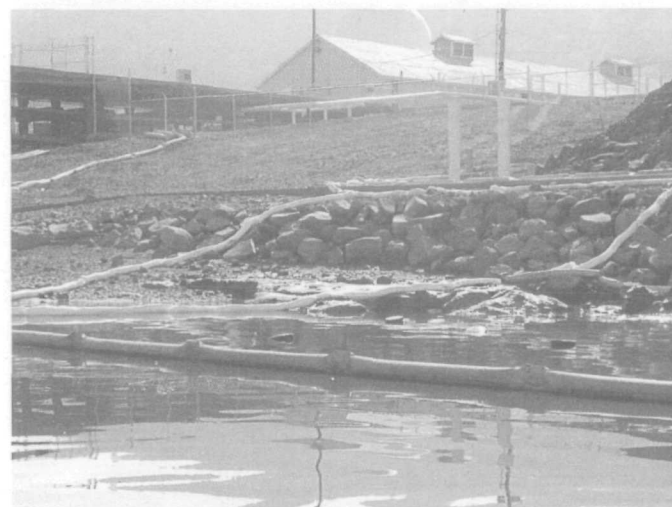
Photo 43: Chevron facility (between Conoco/Phillips and Chevron docks). Seep at base of riprap slope on silty/clayey beach. Iron oxide staining on riprap, moss growth and petroleum-like staining observed. No sheen observed.

Photo 44: Chevron facility (between Conoco/Phillips and Chevron docks). Same as Photo 43

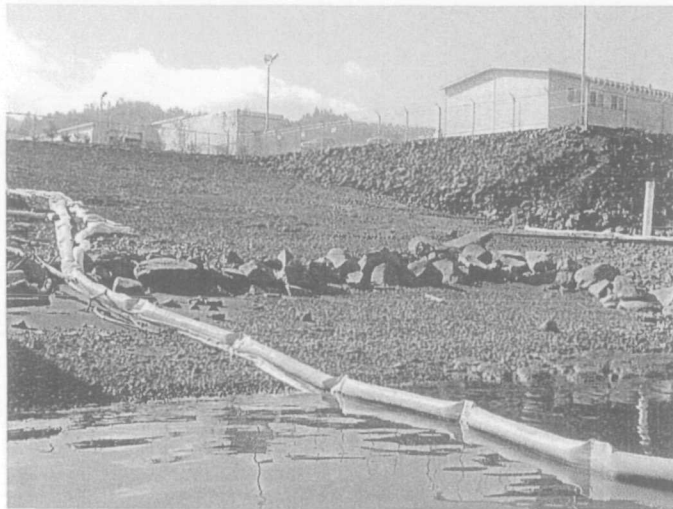
Photo 45: Chevron facility (between Conoco/Phillips and Chevron docks). Iron oxide staining of rock above beach. Remainder is same as photos 43 and 44.

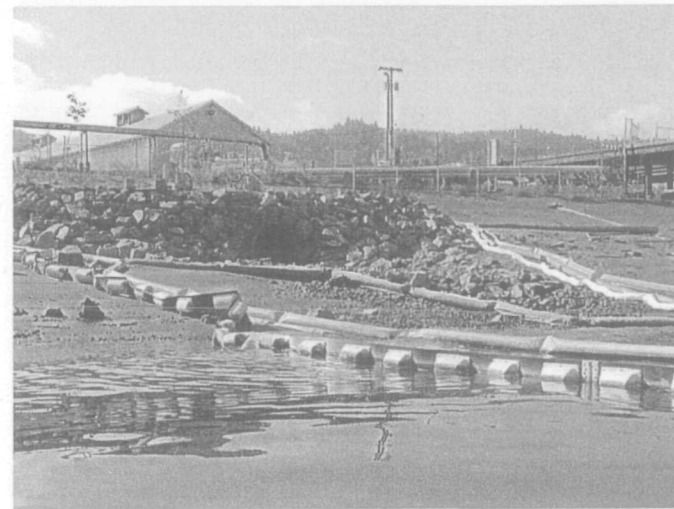
Photo 46: Conoco/Phillips facility (south side of Conoco/Phillips dock). Location of past groundwater seepage through backfill surrounding COP Outfall 22. Outfall surrounded by containment and sorbent booms. No seepage around outfall observed.

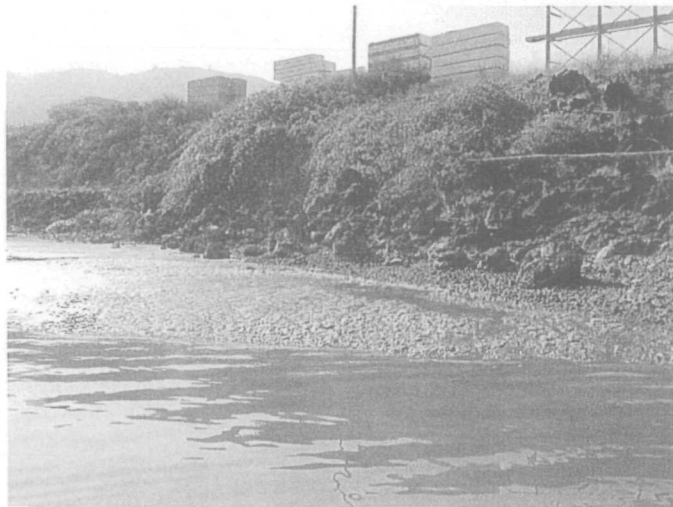
Photo 47: Tube Forgings facility. Seep line at base of embankment where fine-grained sediment crops out at the foot of the slope.

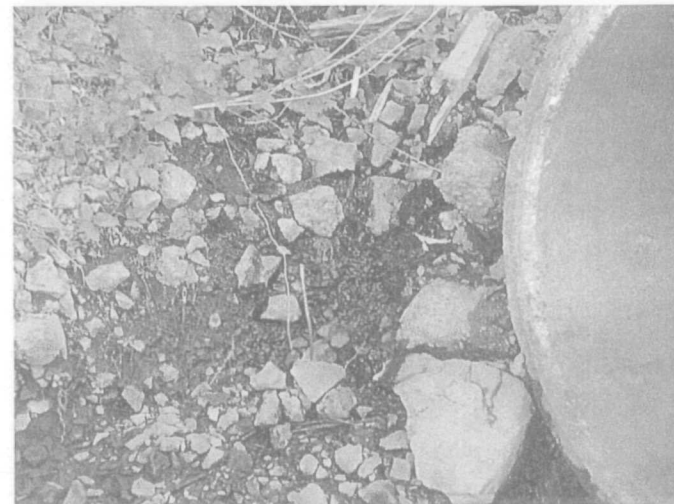
Photo 48: Gunderson facility. Apparent seepage adjacent to COP Outfall 18 (Est. 1 gpm). Source of seepage is uncertain.

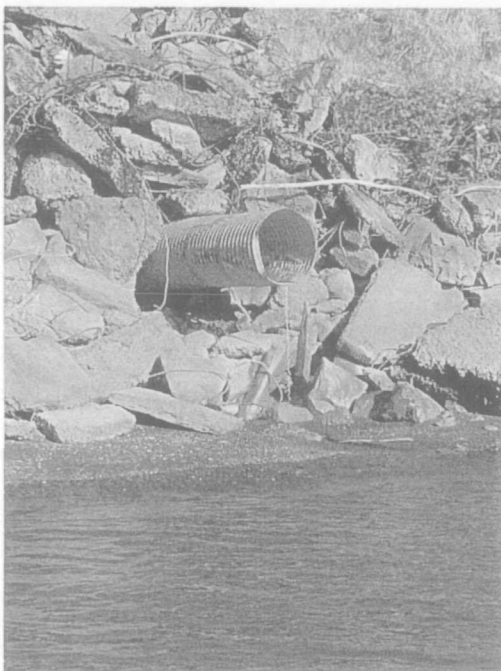
Photo 49: North end of Goldendale Aluminum facility. Heavily corroded steel outfall with iron oxide staining on concrete debris riprap surrounding outfall.

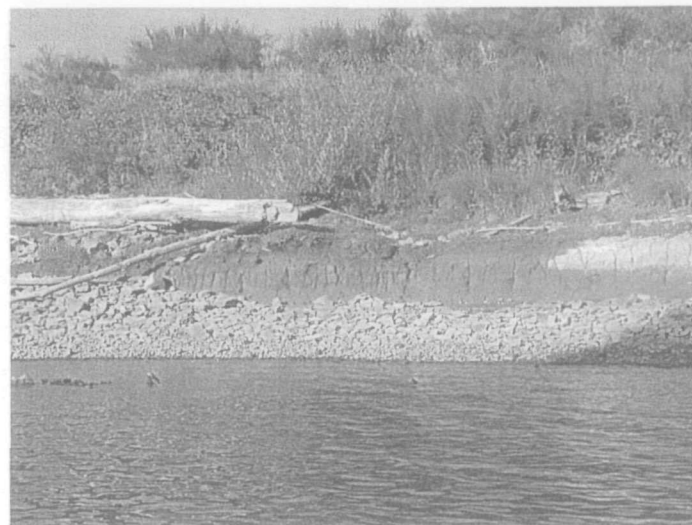
Photo 50: South end of Cascade Shipyard. Linear seep along 20' length above rocky beach. Seepage is at base of a steep embankment where fine-grained soil crops out.
